# DIVISION 1 - CONDITION ASSESSMENTS

## 1.1 Lafayette Head Start

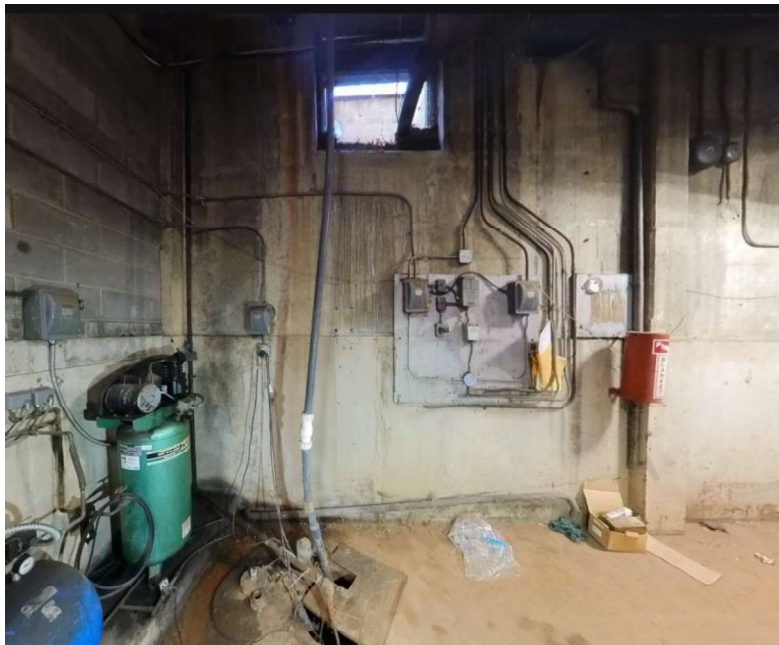
- 4). Photo of Boiler Room Opening and Sump Pump:

- 3). The opening appears to be a direct avenue for heavy rains and snow to enter the room. There is a sump pump located below the opening. The functionality of the sump was not observed at the time; however, PGPC did observe water in the sump which was not above where the activation float would have commanded the pump to run which indicated it was functional.

- 5). **PGPC recommends installation of a louver, and an insulated low-leakage motorized damper interlocked with the operation of the boiler burner. Additional work would be required to relocate the plumbing pipe which extends through the opening.**

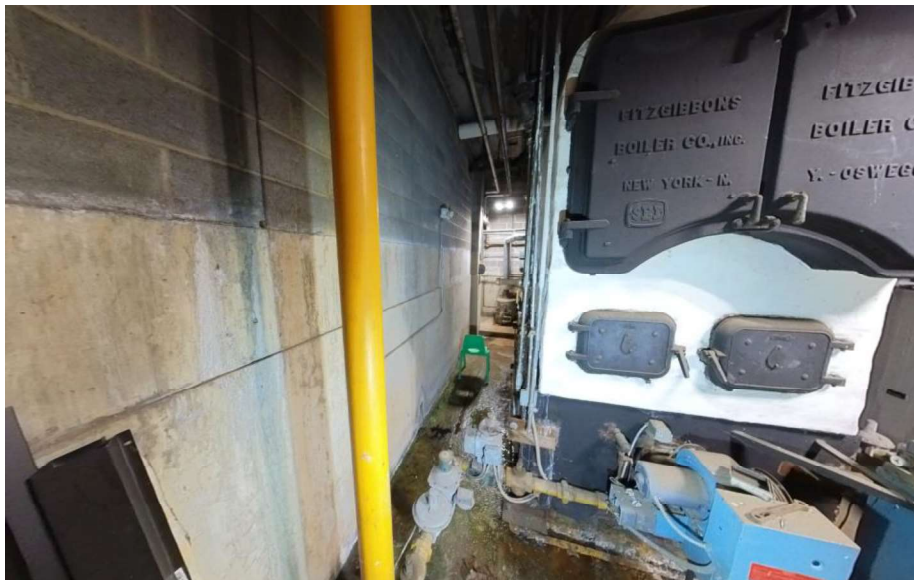
- 1). PGPC observed surface ponding on the south side of the boiler room behind the abandoned boiler indicating signs of water infiltration and algae growth. The leak was traced back to a cored opening at the base of the foundation which extended into the south crawlspace.
- 2). **PGPC recommends further investigation of the source of water infiltration and monitoring the issue to avoid further damage to property and development hazardous conditions in the space. The pooling water and algae growth should be cleaned up and dried out to avoid potential for a slip hazard and potential injury.**
- 3). Photo of Boiler Room Water Infiltration

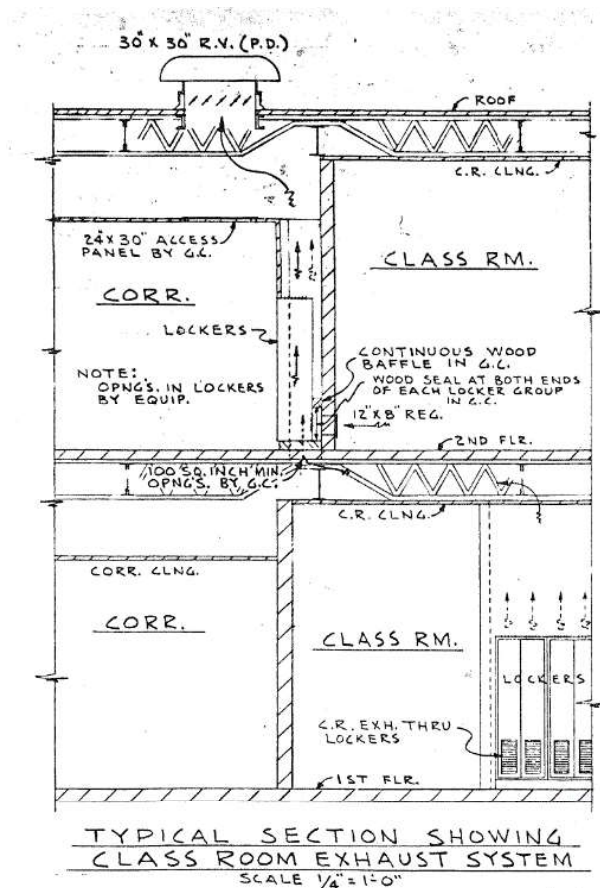
5. Classroom Exhaust Ventilation
    - a. The building was originally provided with classroom ventilation that would exhaust air through vents in the classroom lockers and up through wall cavities into the ceiling. This is a non-ducted system with air drawn through the wall cavity up to a roof mounted exhaust ventilator as depicted below.

- b. Based on field observations, it does not appear that lockers of this type are provided in classrooms as they have transitioned to cubbies for younger students. The building was originally built as a school for grades Kindergarten through 6<sup>th</sup> Grade; however, today it is only used for infants and toddlers in the early head start program.
- c. The 30"x30" roof ventilator is still on the roof; however, the system is not needed or required.

- d. **It is recommended that the roof vent be sealed off beneath the roof or capped above the roof temporarily to avoid increased building energy usage until the vent can be removed during future roof replacement.**
