## 1.0 EXECUTIVE SUMMARY

Peterson Guadagnolo Consulting Engineers P.C. (PGPC) was engaged to complete a high-level assessment of their facilities to assist the agency in the development of future renovation plans for their buildings. The intent of the assessment was to support the efforts of PEACE, Inc.'s Board of Directors and staff, to ensure that the facilities remain secure and well-maintained, employees can do their job, and clients can receive services in pleasant, clean, and safe environments.

At the direction of PEACE, PGPC performed an assessment in the following ten (10) Agency buildings:

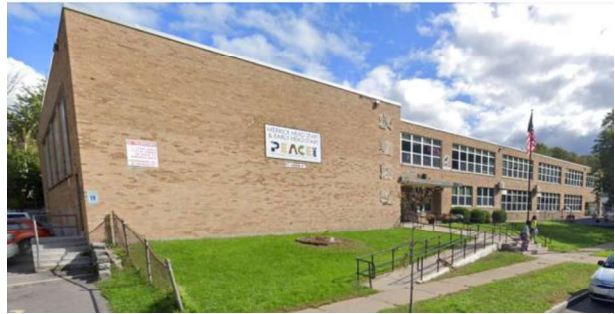
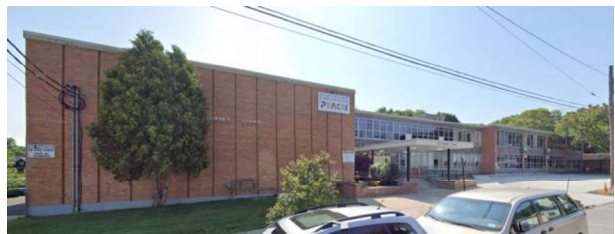
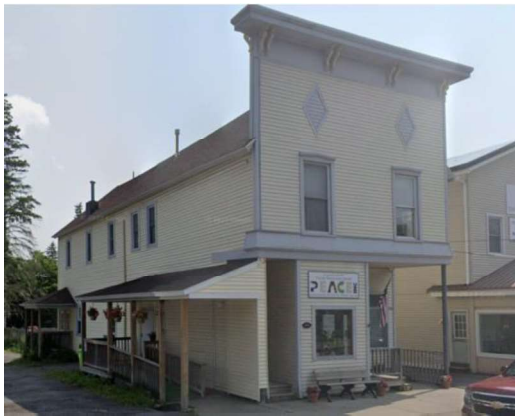
While these buildings are the two largest facilities and were both in “good” condition overall, their finishes are dated and beginning to show age. The physical size of these buildings contributed to lower FCI scores due to their comparable replacement value. The majority of the deferred maintenance in these buildings is related to their envelopes and should be considered for near term roof and window replacements in order to maintain weather durability and to improve building energy consumption. In addition, the heating systems are in need of renovation in the next 10 years. Although the facility’s boilers were replaced recently, consideration should be given to replace the steam distribution piping and equipment in both buildings due to the age of vintage unit ventilators, distribution piping and convectors. Performing mechanical upgrades will also offer energy savings and ventilation improvement opportunities.

| 5) Merrick Head Start – Study, evaluate and design heating system replacement | \$ 60,000 |
| 6) Sumner Head Start – Study, evaluate and design heating system replacement | \$ 60,000 |
| 7) Sumner Head Start – Roof Planning and Replacement | \$400,000 |
| 8) Merrick Head Start – Roof Planning and Replacement | \$250,000 |

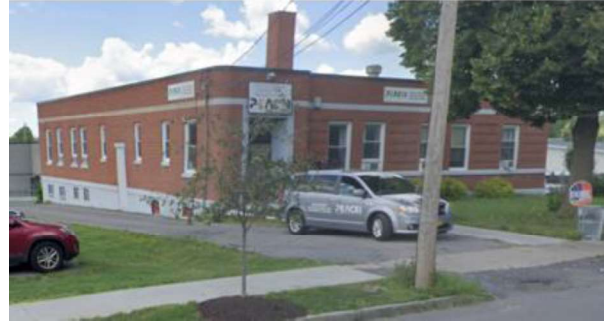
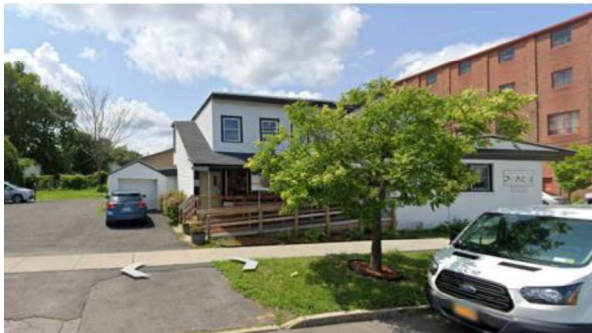
**3.5 Eastside Family Resource Center** - FCI is relatively high due and rated as “poor” due to its legacy boiler and original terminal unit and piping system which has exceeded its anticipated life expectancy. Additional concerns to address are the age and condition of the under slab combined sanitary/storm piping system which is believed to be clay tile construction and potentially compromised with tree root systems. There are reports of historical flooding and backup issues at the facility and due to the age of the structure, significant investment could be required if repair of the piping system is needed. Focus and careful consideration should be directed towards future renovation(s) surrounding building thermal envelope upgrades and replacement of the building heating system to incorporate centralized mechanical ventilation and air conditioning which is currently non-existent in the historically naturally ventilated facility.

| 1) Eastside Family Resource Center – Replace legacy boiler system and heating units | \$170,000 |
| 2) Eastside Family Resource Center – Investigate & repair building sewer lateral | \$ 10,000 |

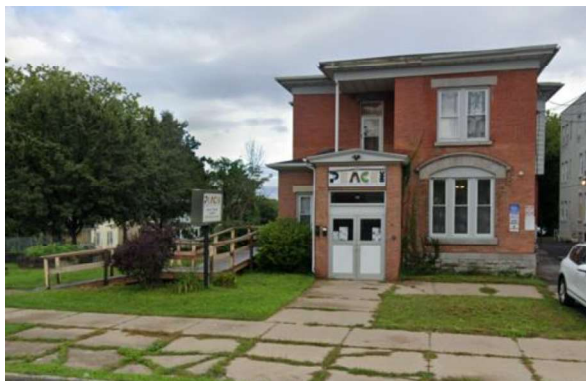
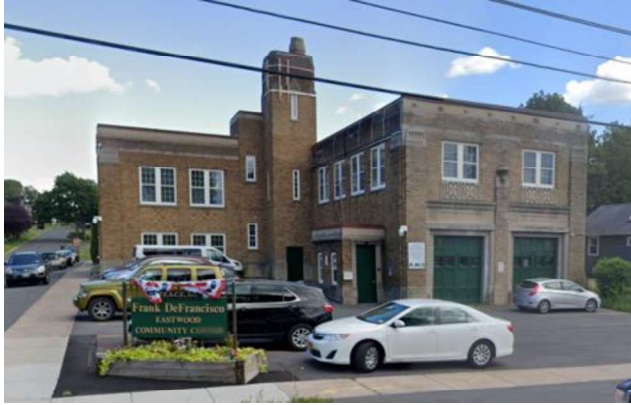
Both of these properties conveyed as “poor” with major issues related to water infiltration into the basement which has resulted in considerable deterioration and dilapidation. This was reflected in the condition of the foundations, basement flooring assemblies and the mechanical systems serving the buildings. Both Resource Centers are strategically located which makes them valuable in the respect that they reach the communities in which they serve where they are needed most. However, in addition to structural, building envelope, and deferred maintenance of systems, the facilities are both limited in their programmatic capability due to poor use of space and accessibility concerns. It is recommended that careful consideration be placed in addressing the future needs of the program and use of the facility’s space prior to tackling the significant investment(s) required to address the deferred maintenance of both facilities.

In addition, it is recommended that the Westside and Southside Family Resource Centers be evaluated separately as to their long-term viability. Due to the extent of deterioration of the facilities and the extent of work needed to restore the structure, envelope and main mechanical systems the Agency should consider selling the properties and relocating to another site (purchase or lease) or consider full demolition and rebuilding on the same site. During the assessment there was discussion related to the programmatic needs of both sites which might be accomplished more effectively with a new building.

- 17) Westside Family Resource Center (200 Wyoming Street) - Review overall programmatic need of this location. If it is decided to retain the property and provide service at this site, significant investment is necessary.
  - a. Range of investment cost for existing structure, envelope and critical items \$150,000
- 18) Southside Family Resource Center (136 Dr. Martin Luther King West) - Review overall programmatic need of this location. If it is decided to retain the property and provide service at these locations, significant investment is necessary.
  - a. Range of investment cost for existing structure, envelope and critical items \$225,000

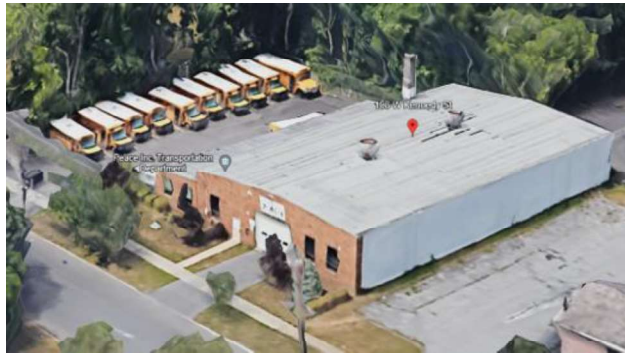
FCI is relatively high due to a few open masonry and roof issues at the time of the assessment that were not completed and therefore included in the overall score. Current FCI rating of the facility is “fair” as the Agency addressed the hose tower and other roof and masonry issues in 2024 that was the most important envelope issue, and which will greatly extend the life of the facility. With exception to envelope concerns, additional focus should be directed to preventative maintenance of the aging HVAC and heating systems which is essential in facilities with wet pipe sprinkler

and plumbing systems due to freezing concerns. Building air handler and air conditioning/heating needs were identified, although the anticipated schedule for replacement is not immediate. With the benefit of a robust structure and with proper preventative maintenance of building systems, the facility offers years of continued service to the community and has great potential for future renovations.

| 3) DeFrancisco Eastwood Community Center – Envelope and roof repairs | \$ 60,000 |
| 4) DeFrancisco Eastwood Community Center – Replace duct furnaces | \$ 20,000 |

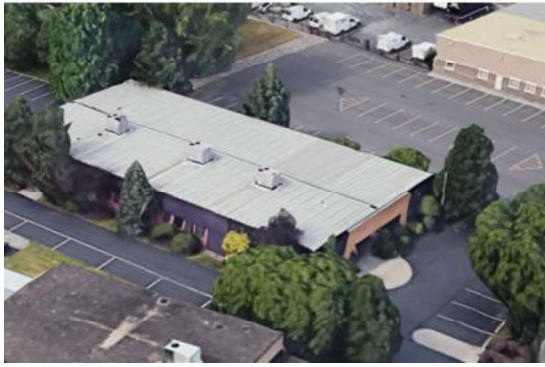
has an FCI higher than what might be expected as the facility has a steam heating system that is nearing end of life, and a total replacement with a new modern system is recommended. Overall, with attention to some general deferred maintenance items, the facility is in “fair” condition and well suited for its current use. The Transportation Center plays a critical role in the function of the Agency’s head start facilities with its fleet of busses that serve the community. Addressing

the continued damage to the vehicles exhaust systems caused by the steep graded entry drive into the facility’s parking lot should be addressed.

| 9) Transportation Dept – Heating System Replacement | \$120,000 |
| 10) Transportation Dept – Regrade driveway apron (reduce damage to buses) | \$ 25,000 |
